Water Quality in Guana Estuary: From Monitoring to Management

Nikki Dix, Jessica Lee, Olivia Roorbach, Shannon Dunnigan, Savanna Mathis
Guana Tolomato Matanzas National Estuarine Research Reserve

GTMNERR State of the Reserve | February 16, 2023

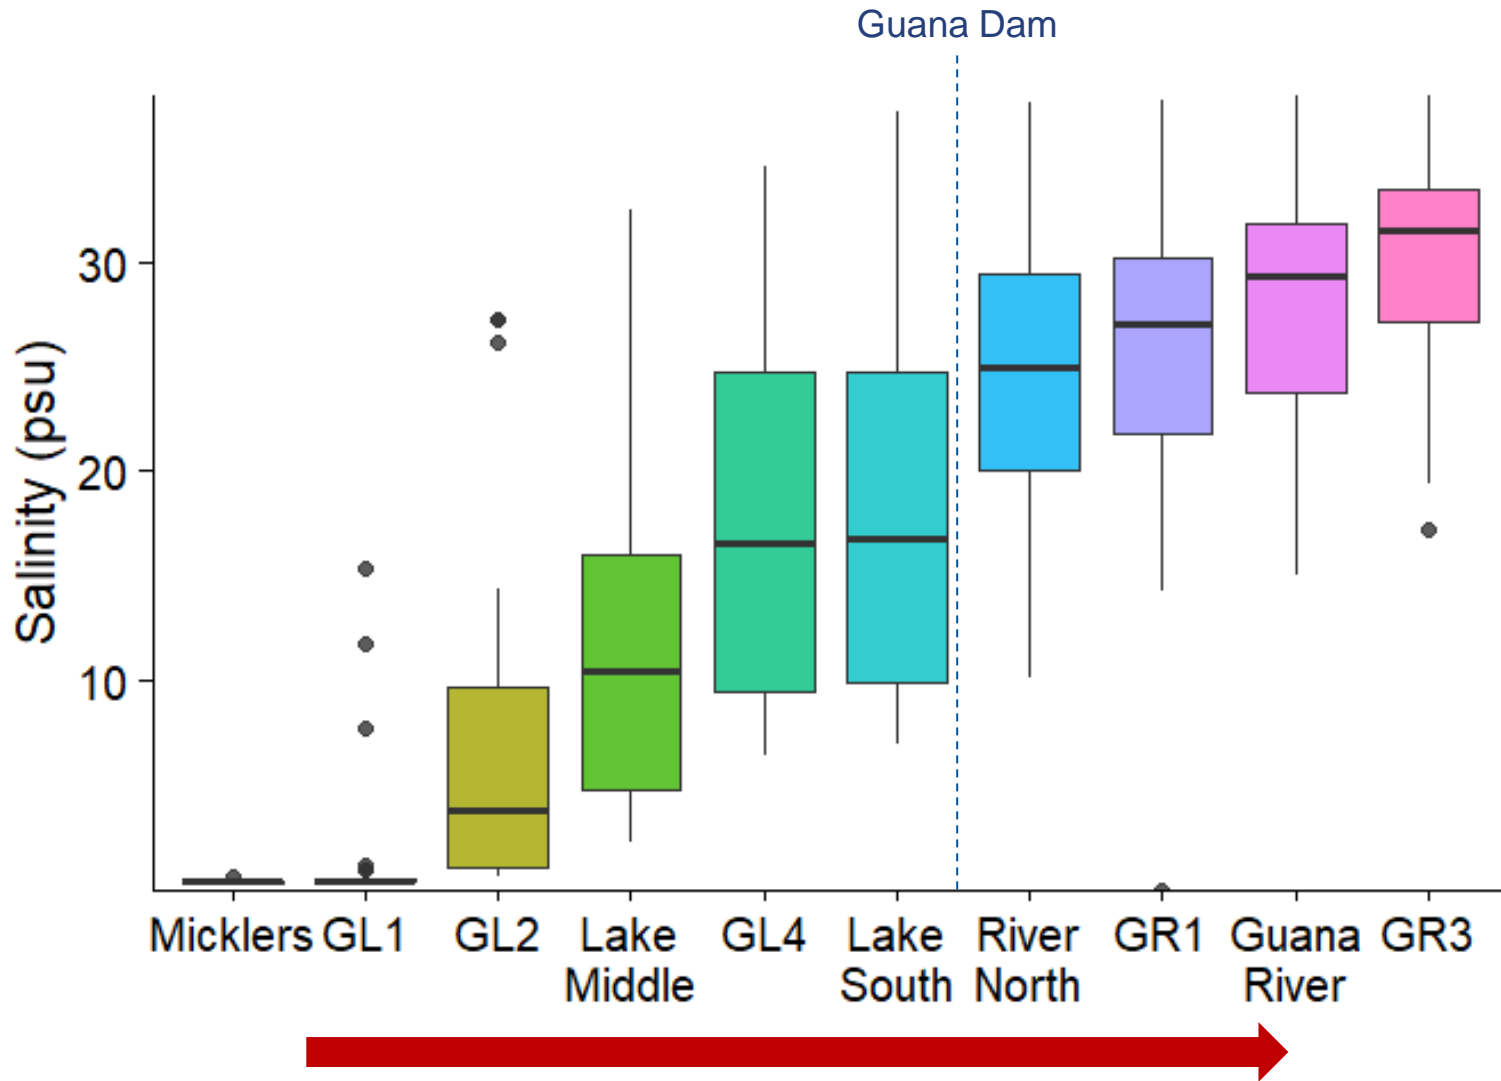
Water Quality Monitoring Salinity Gradient

July 2017 – June 2022

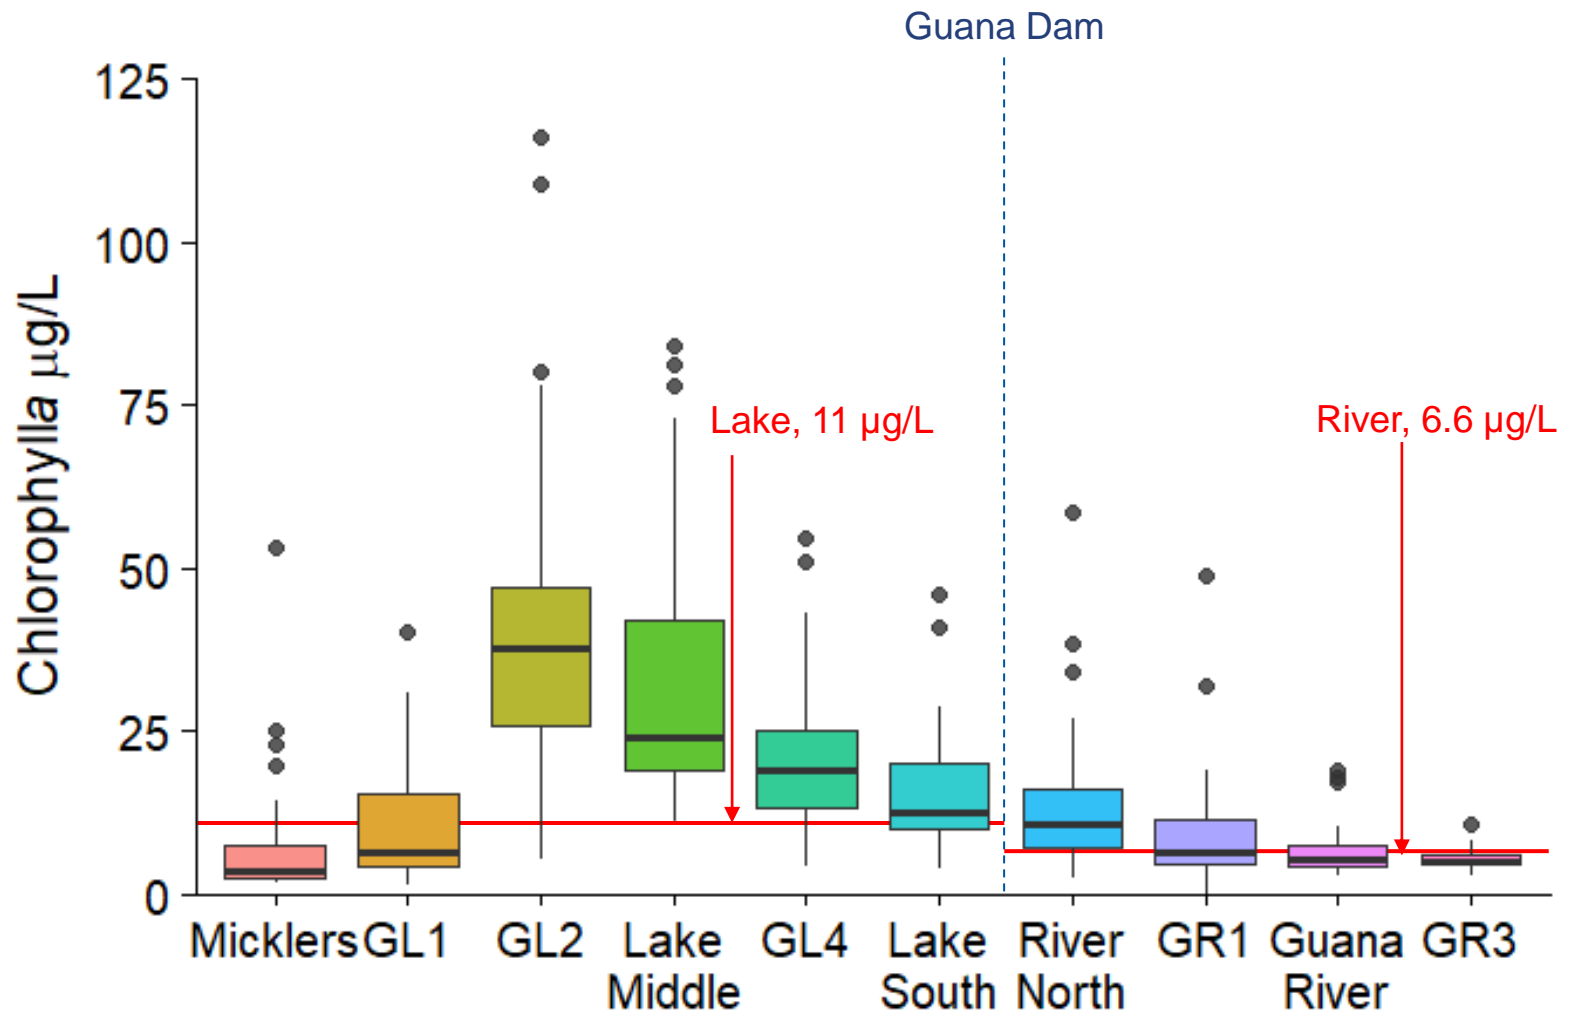
Water Quality Monitoring

Chlorophyll a (phytoplankton biomass)

July 2017 – June 2022

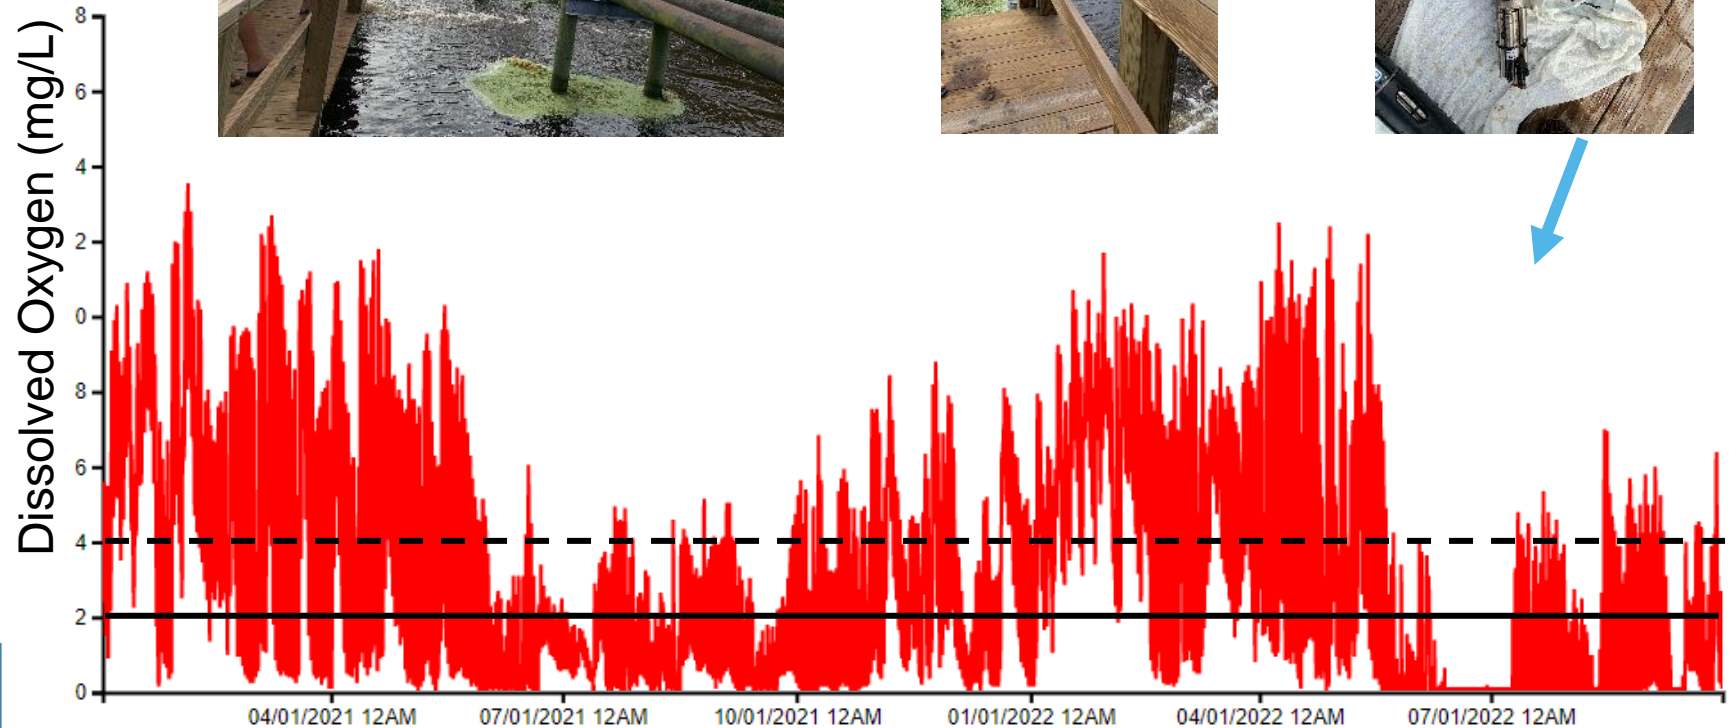
Continuous Water Quality Monitoring October 2020 to Present

Florida Healthy Beaches Program Categories: Good = 0-35; Moderate = 36-70; Poor = 71
