Did the dredging of Summer Haven River impact nearby oyster reefs?

Pamela Marcum, M.S. & Nikki Dix, Ph.D.

Guana Tolomato Matanzas National Estuarine Research Reserve; Ponte Vedra Beach, FL

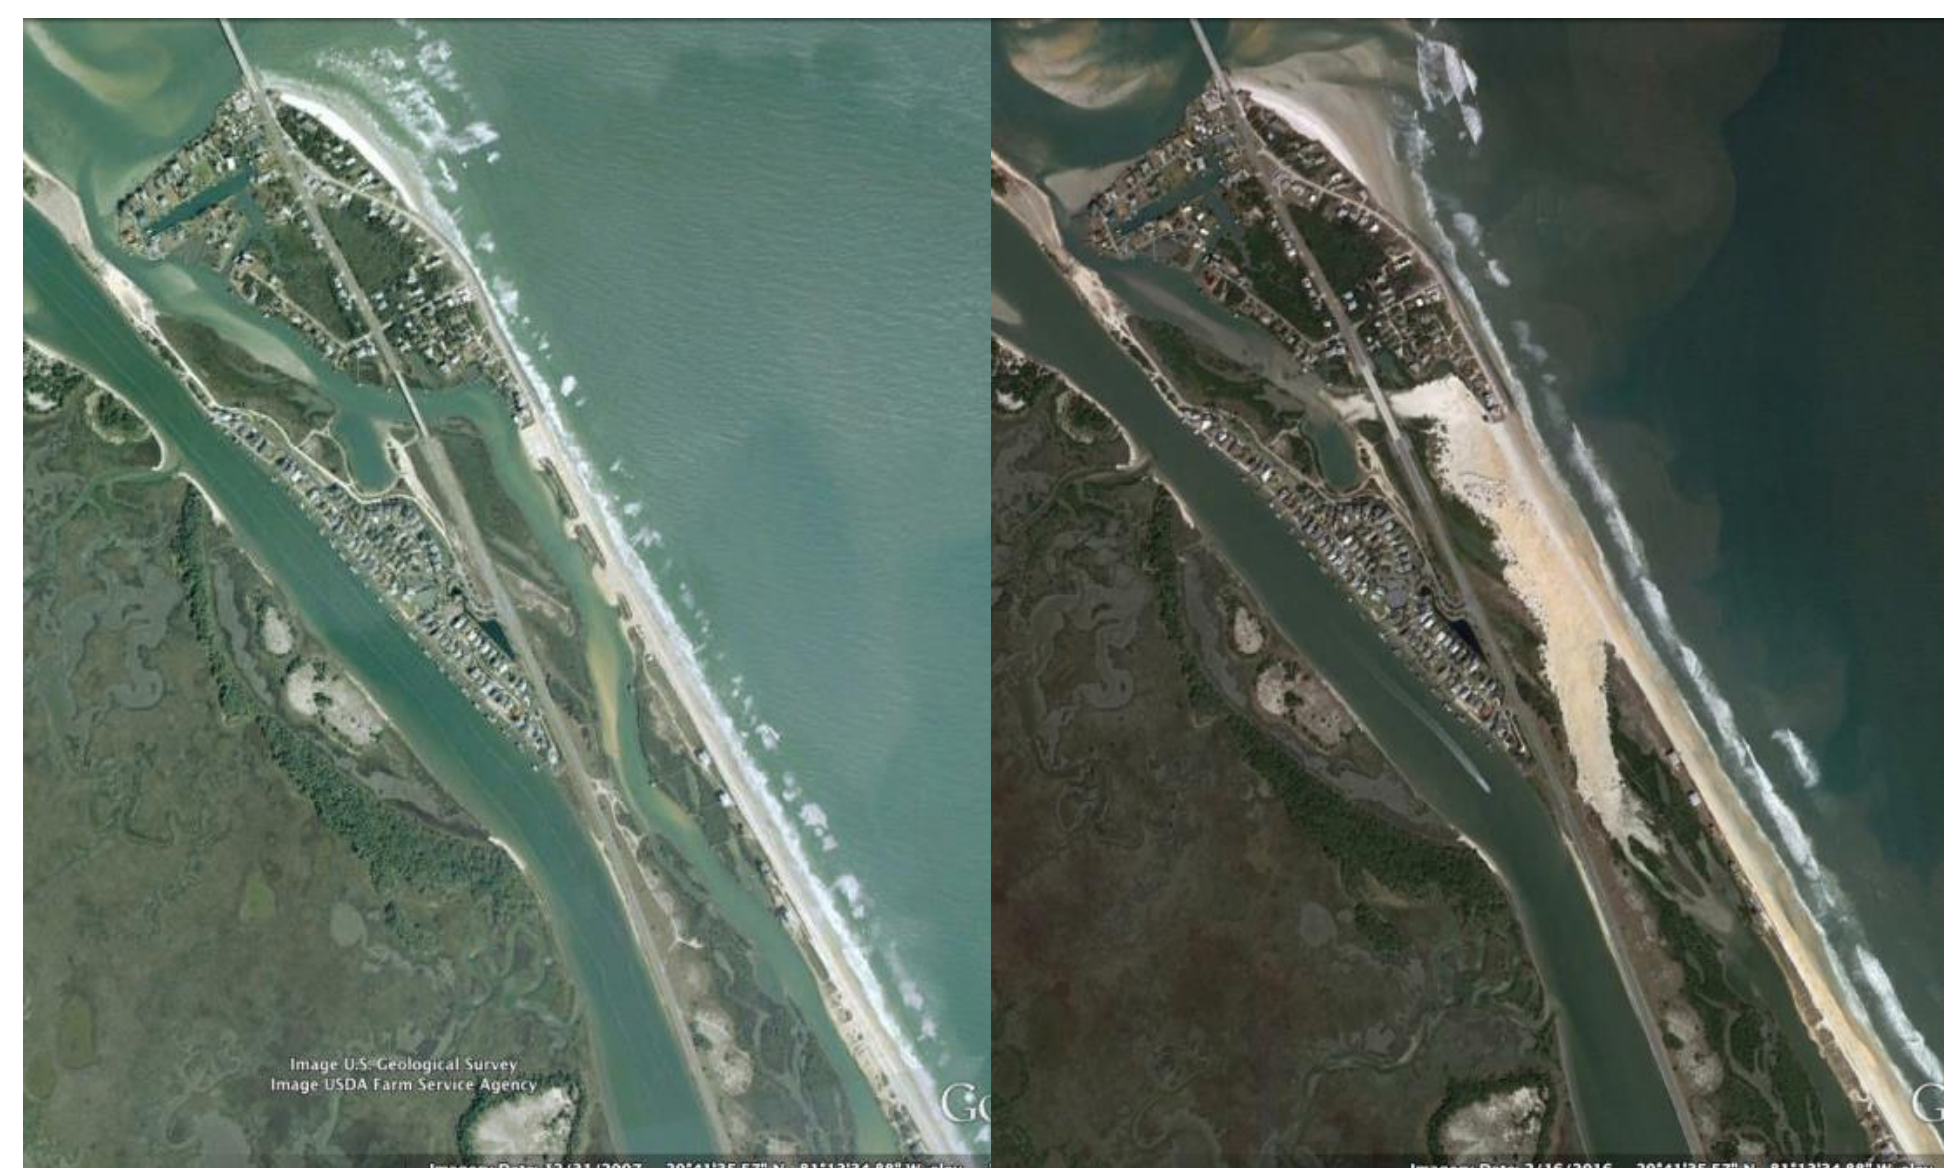
Figure 1 Summer Haven River pre- (left) and post (right) dune breach

The Summer Haven River, located south of the Matanzas Inlet, runs north-south between the Intracoastal Waterway and the Atlantic Ocean, bisecting the barrier island. In 2008, multiple storms caused a dune breach and sand filled in the northern half of the river (Figure 1). In 2016, a dredging project was approved to restore the flow to the river. In response to the dredge project, the GTMNERR initiated an oyster monitoring project to assess any impacts the reefs may face. Oyster reefs provide numerous ecosystem services including habitat, coastal protection, and water filtration; and they are good indicators of water quality. Negative impacts to reefs can result in cascading effects to the ecosystem.

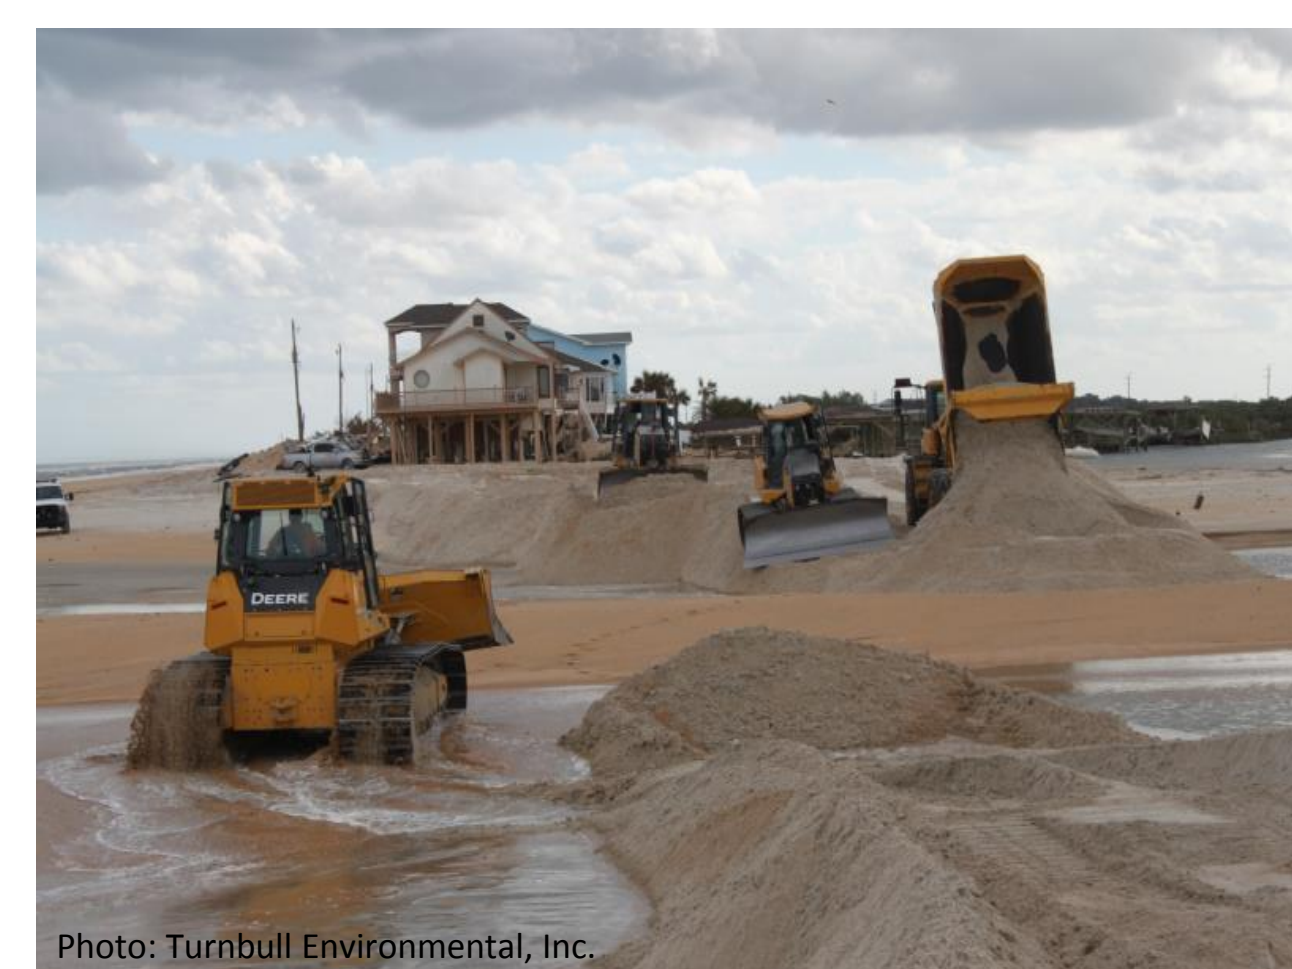
Figure 6 Closing dune breach

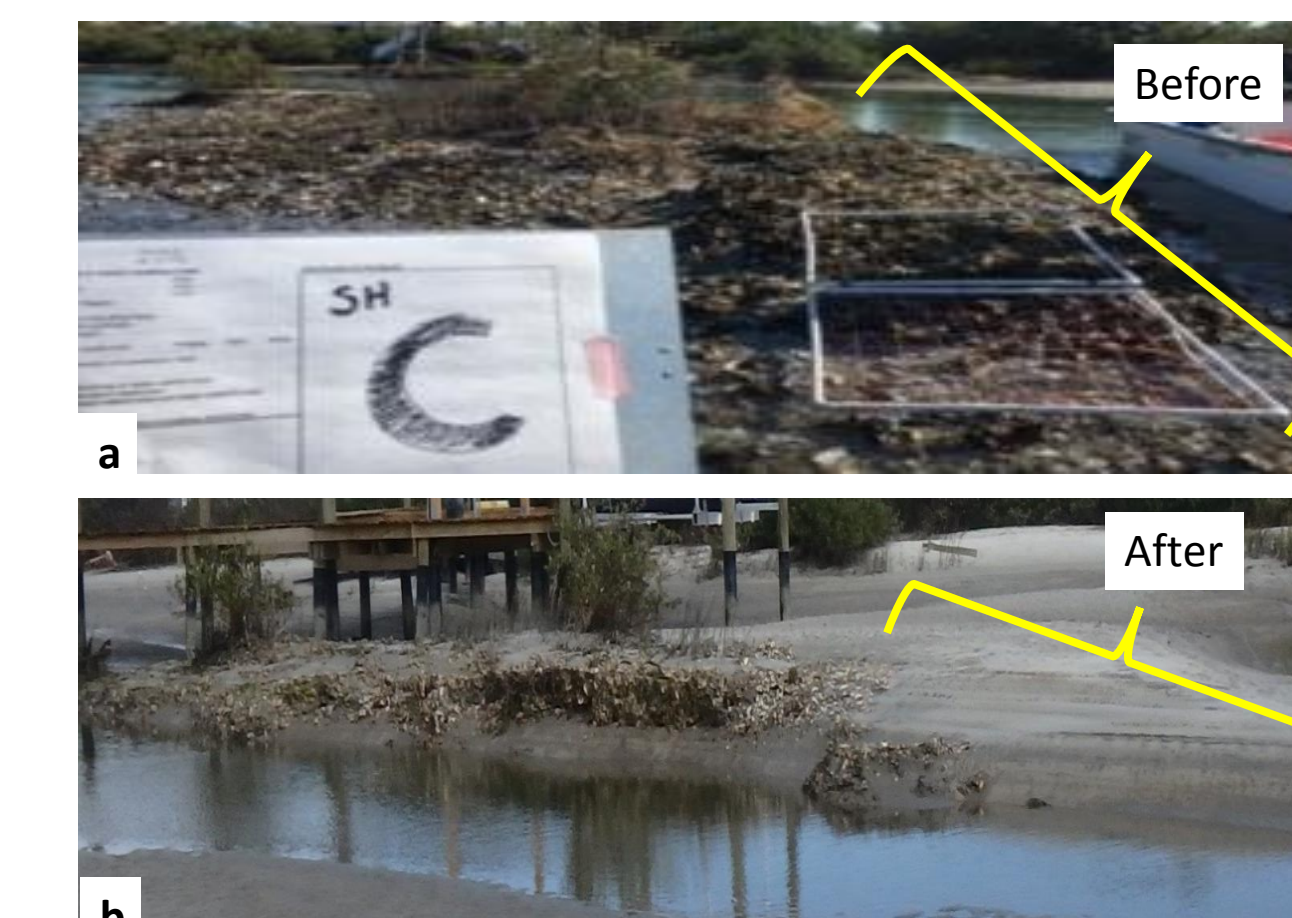
Figure 5 Summer Haven reef lost during dredging a) pre-dredge b) post-dredge

- Shell coverage decreased on Summer Haven reefs
- Sediment coverage increased on Summer Haven and Whitney reefs
- One of the Summer Haven reefs was lost during dredging (Figure 5)
- Oyster densities were not significantly different

- The only direct impact of dredging observed was the loss of one reef in Summer Haven River
- Potential hurricane impacts may be confounding before/after results
- Variations among impact/control sites and small sample sizes may be masking dredge effects
- Continued monitoring is warranted to determine if restored flow will affect reefs in the region
