Establishing a Water Quality Baseline in the Impounded Guana River Estuary

Nikki Dix, Shannon Dunnigan, GTM Research Reserve

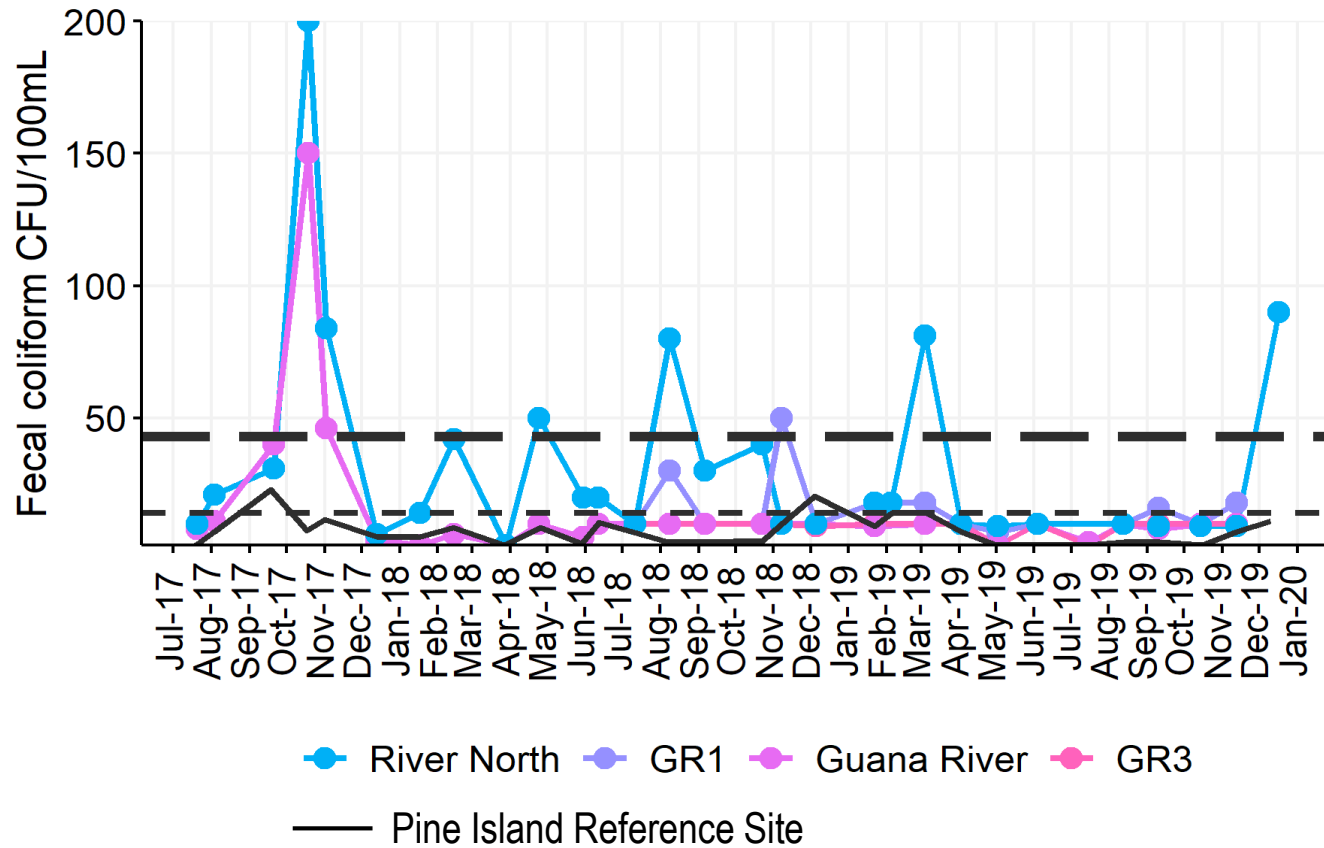
Bacteria

River

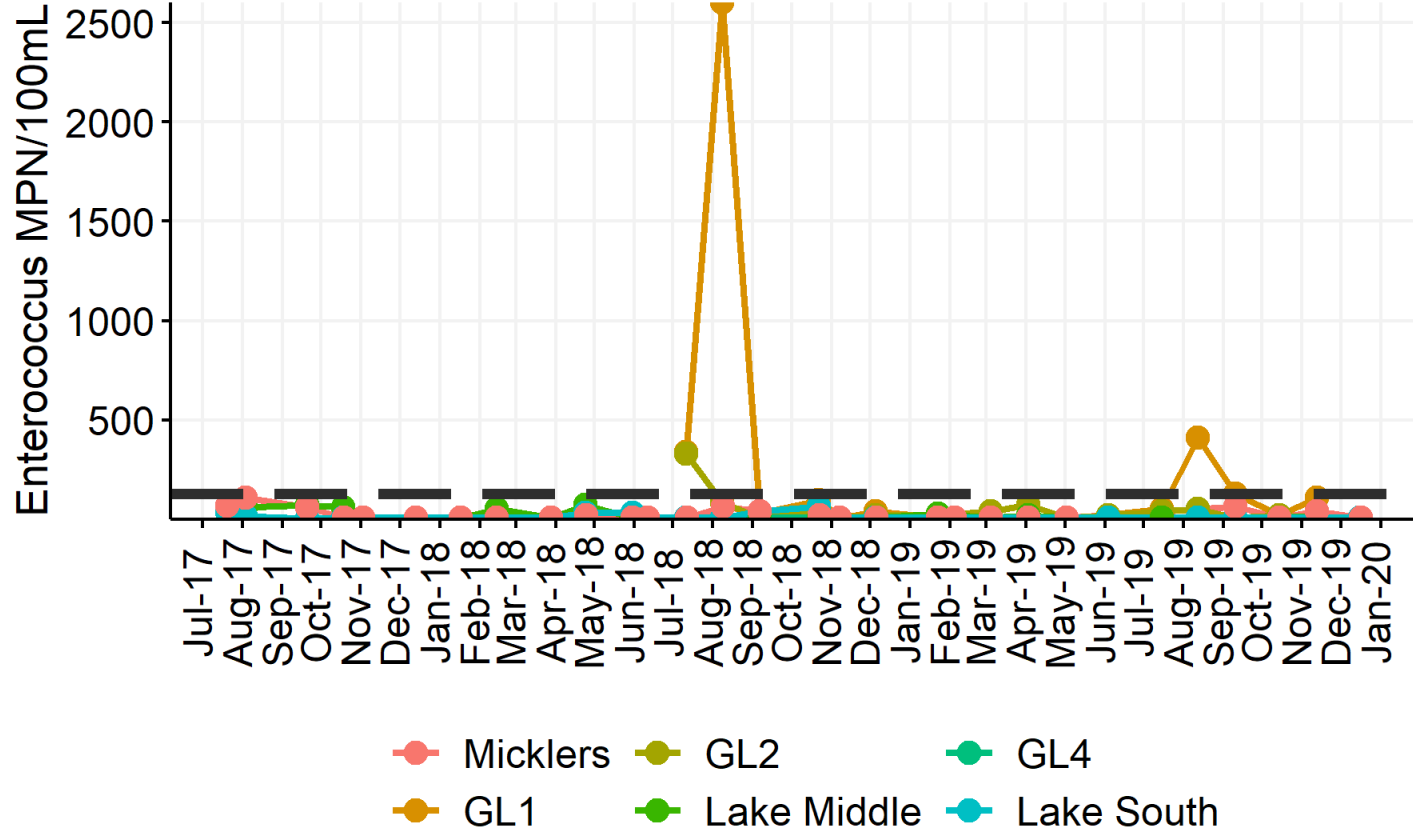
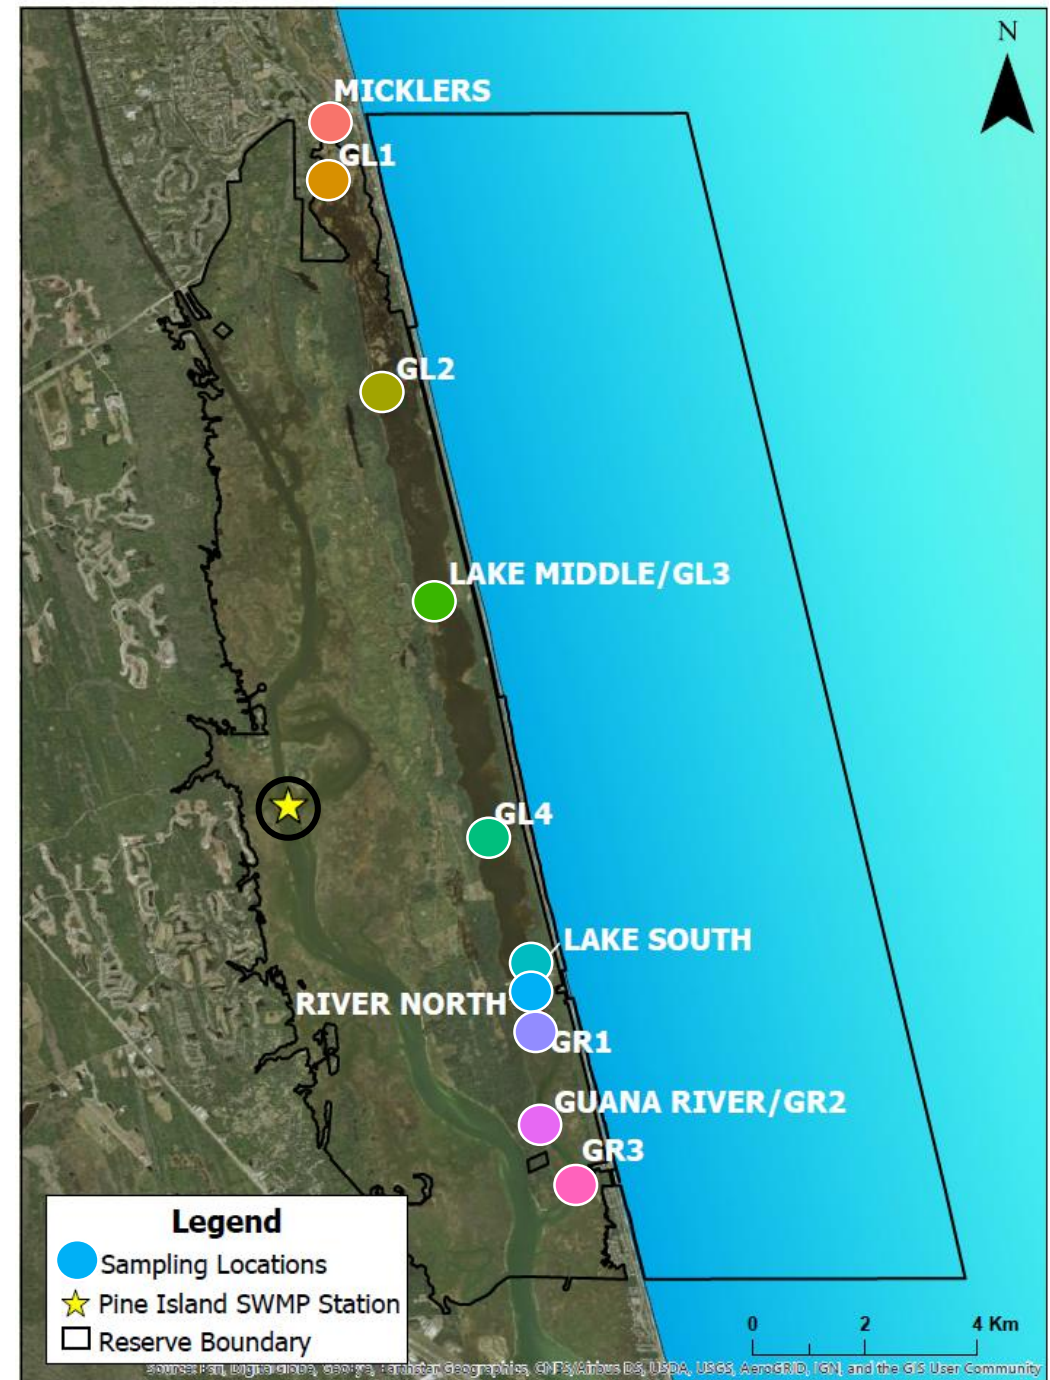
Bacteria

Lake

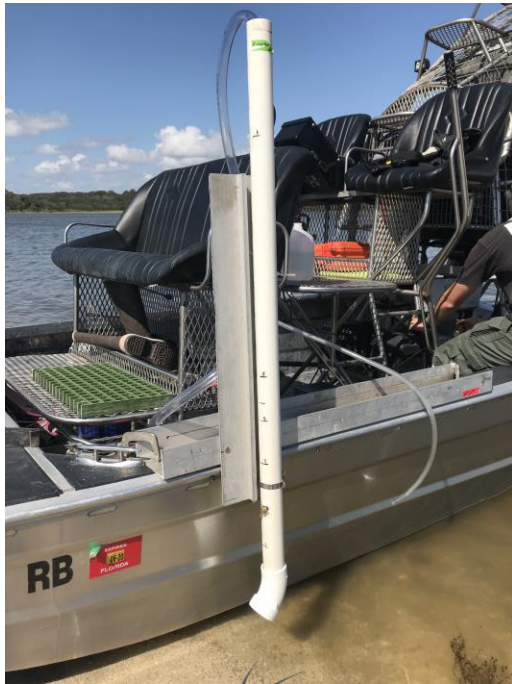
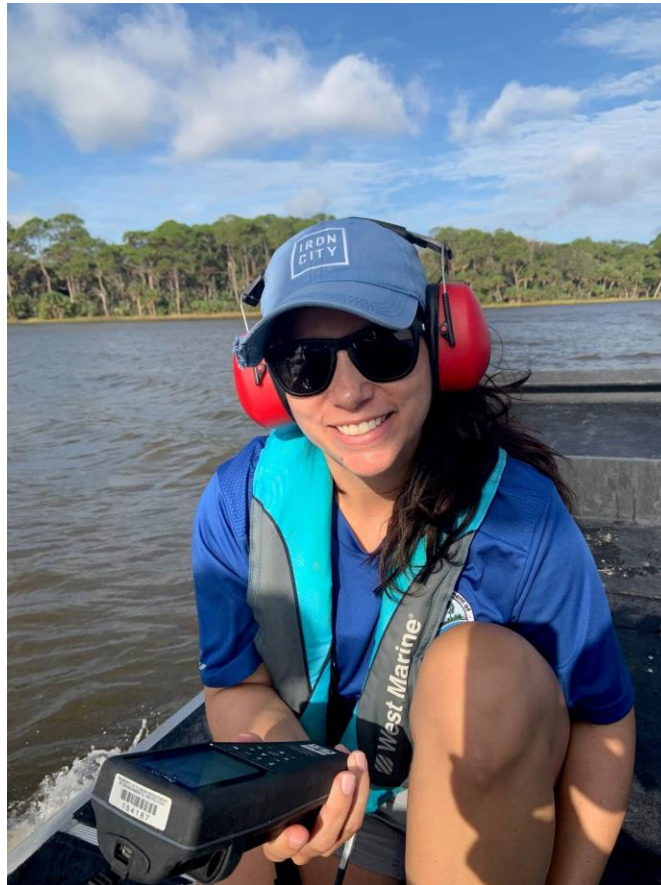
October 16, 2019 Chlorophyll a Concentrations
(Guana Spatial Survey)

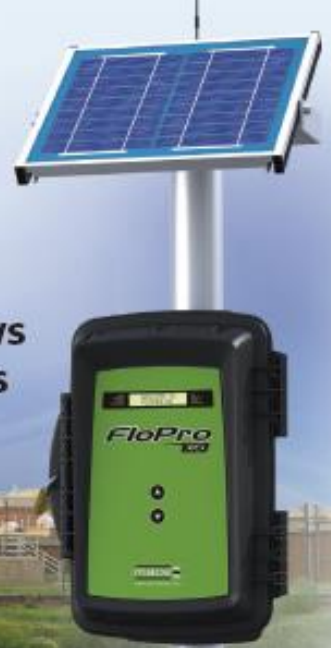
FloPro[®] Xci

Monitor wastewater, stormwater and industrial flows in full pipes, partially full pipes and open channels

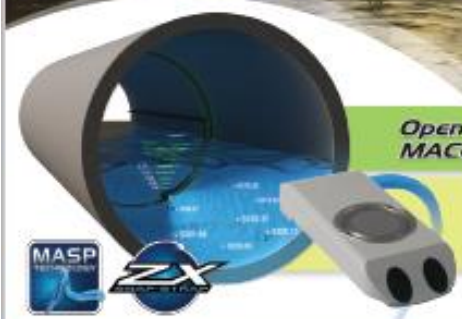
Open channel flow measurement
MACE Area/Velocity Sensor

- ✓ Doppler ultrasonic area/velocity sensor with MASP technology
- ✓ Easy to install in existing pipe work with a MACE ZX SnapTrap
- ✓ Operates in regular and irregular cross-sections
- ✓ Reliable under difficult hydraulic conditions
- ✓ Replaceable ceramic diaphragm depth sensor
