# Do Hardened Structures Accelerate Erosion on Adjacent Properties?

Sydney Hayes, Colin Herbert, Trinity Hopkins, Aubrey Kemper

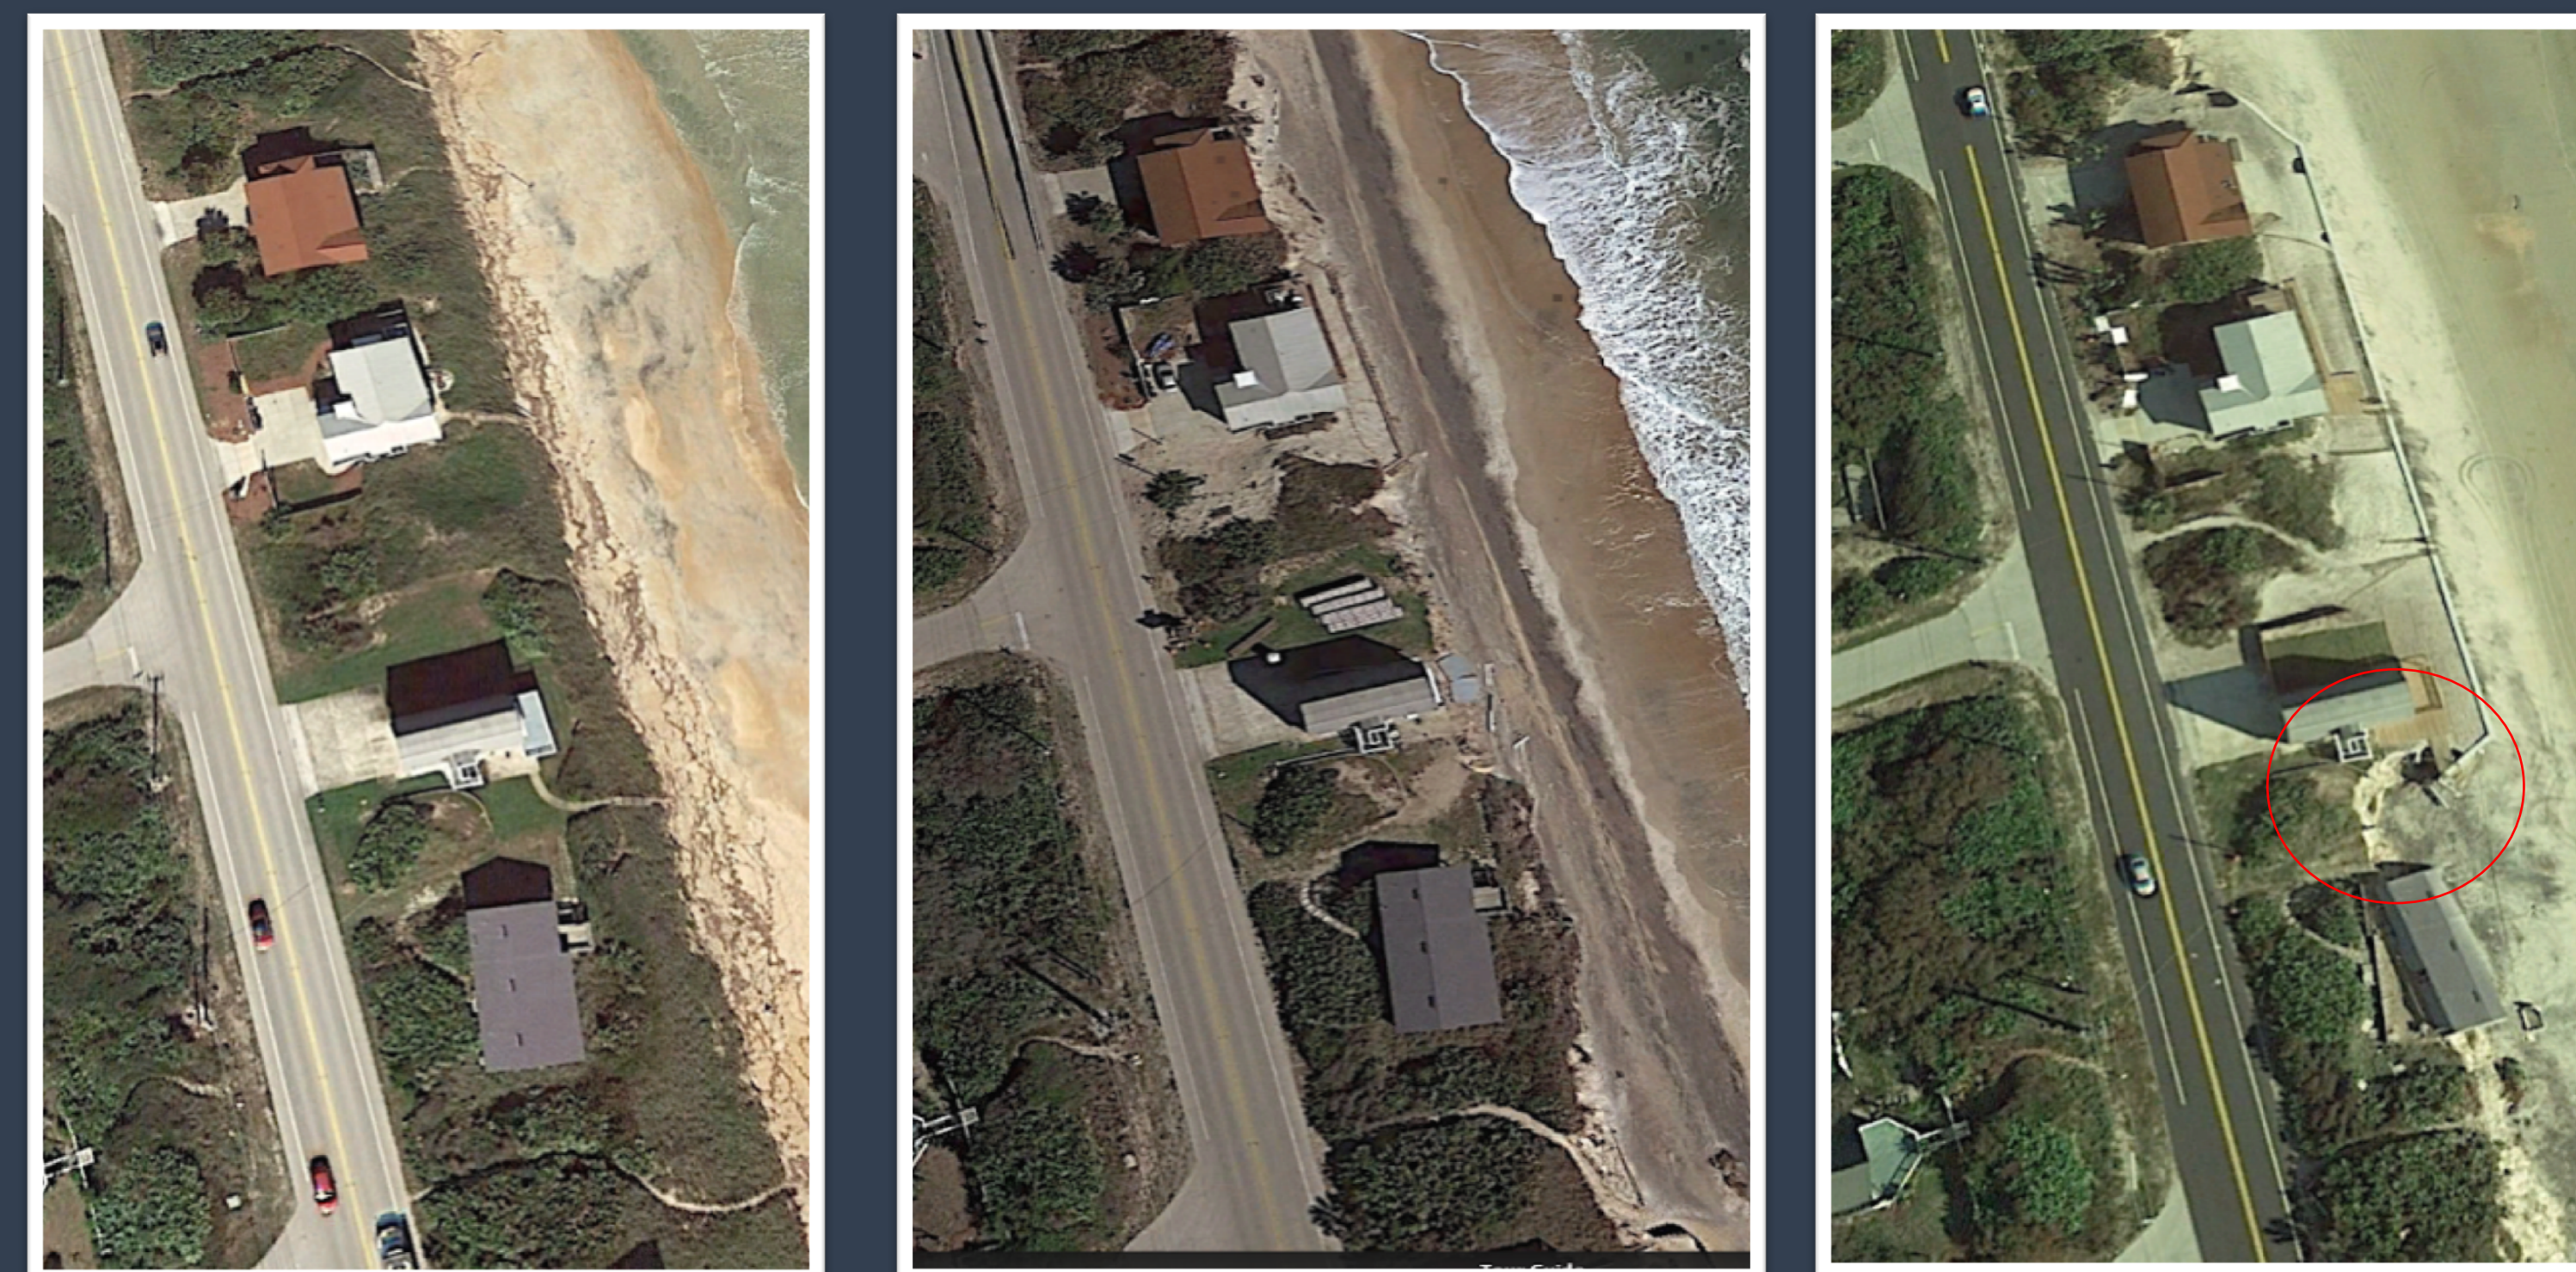
Image 1: For future studies we would like to look at post Hurricane Irma satellite images to help further conclude our hypothesis. Shown above are satellite images, to the left shown by the red circle is the progress of erosion after sever weather events directly adjacent to a hardened structure.

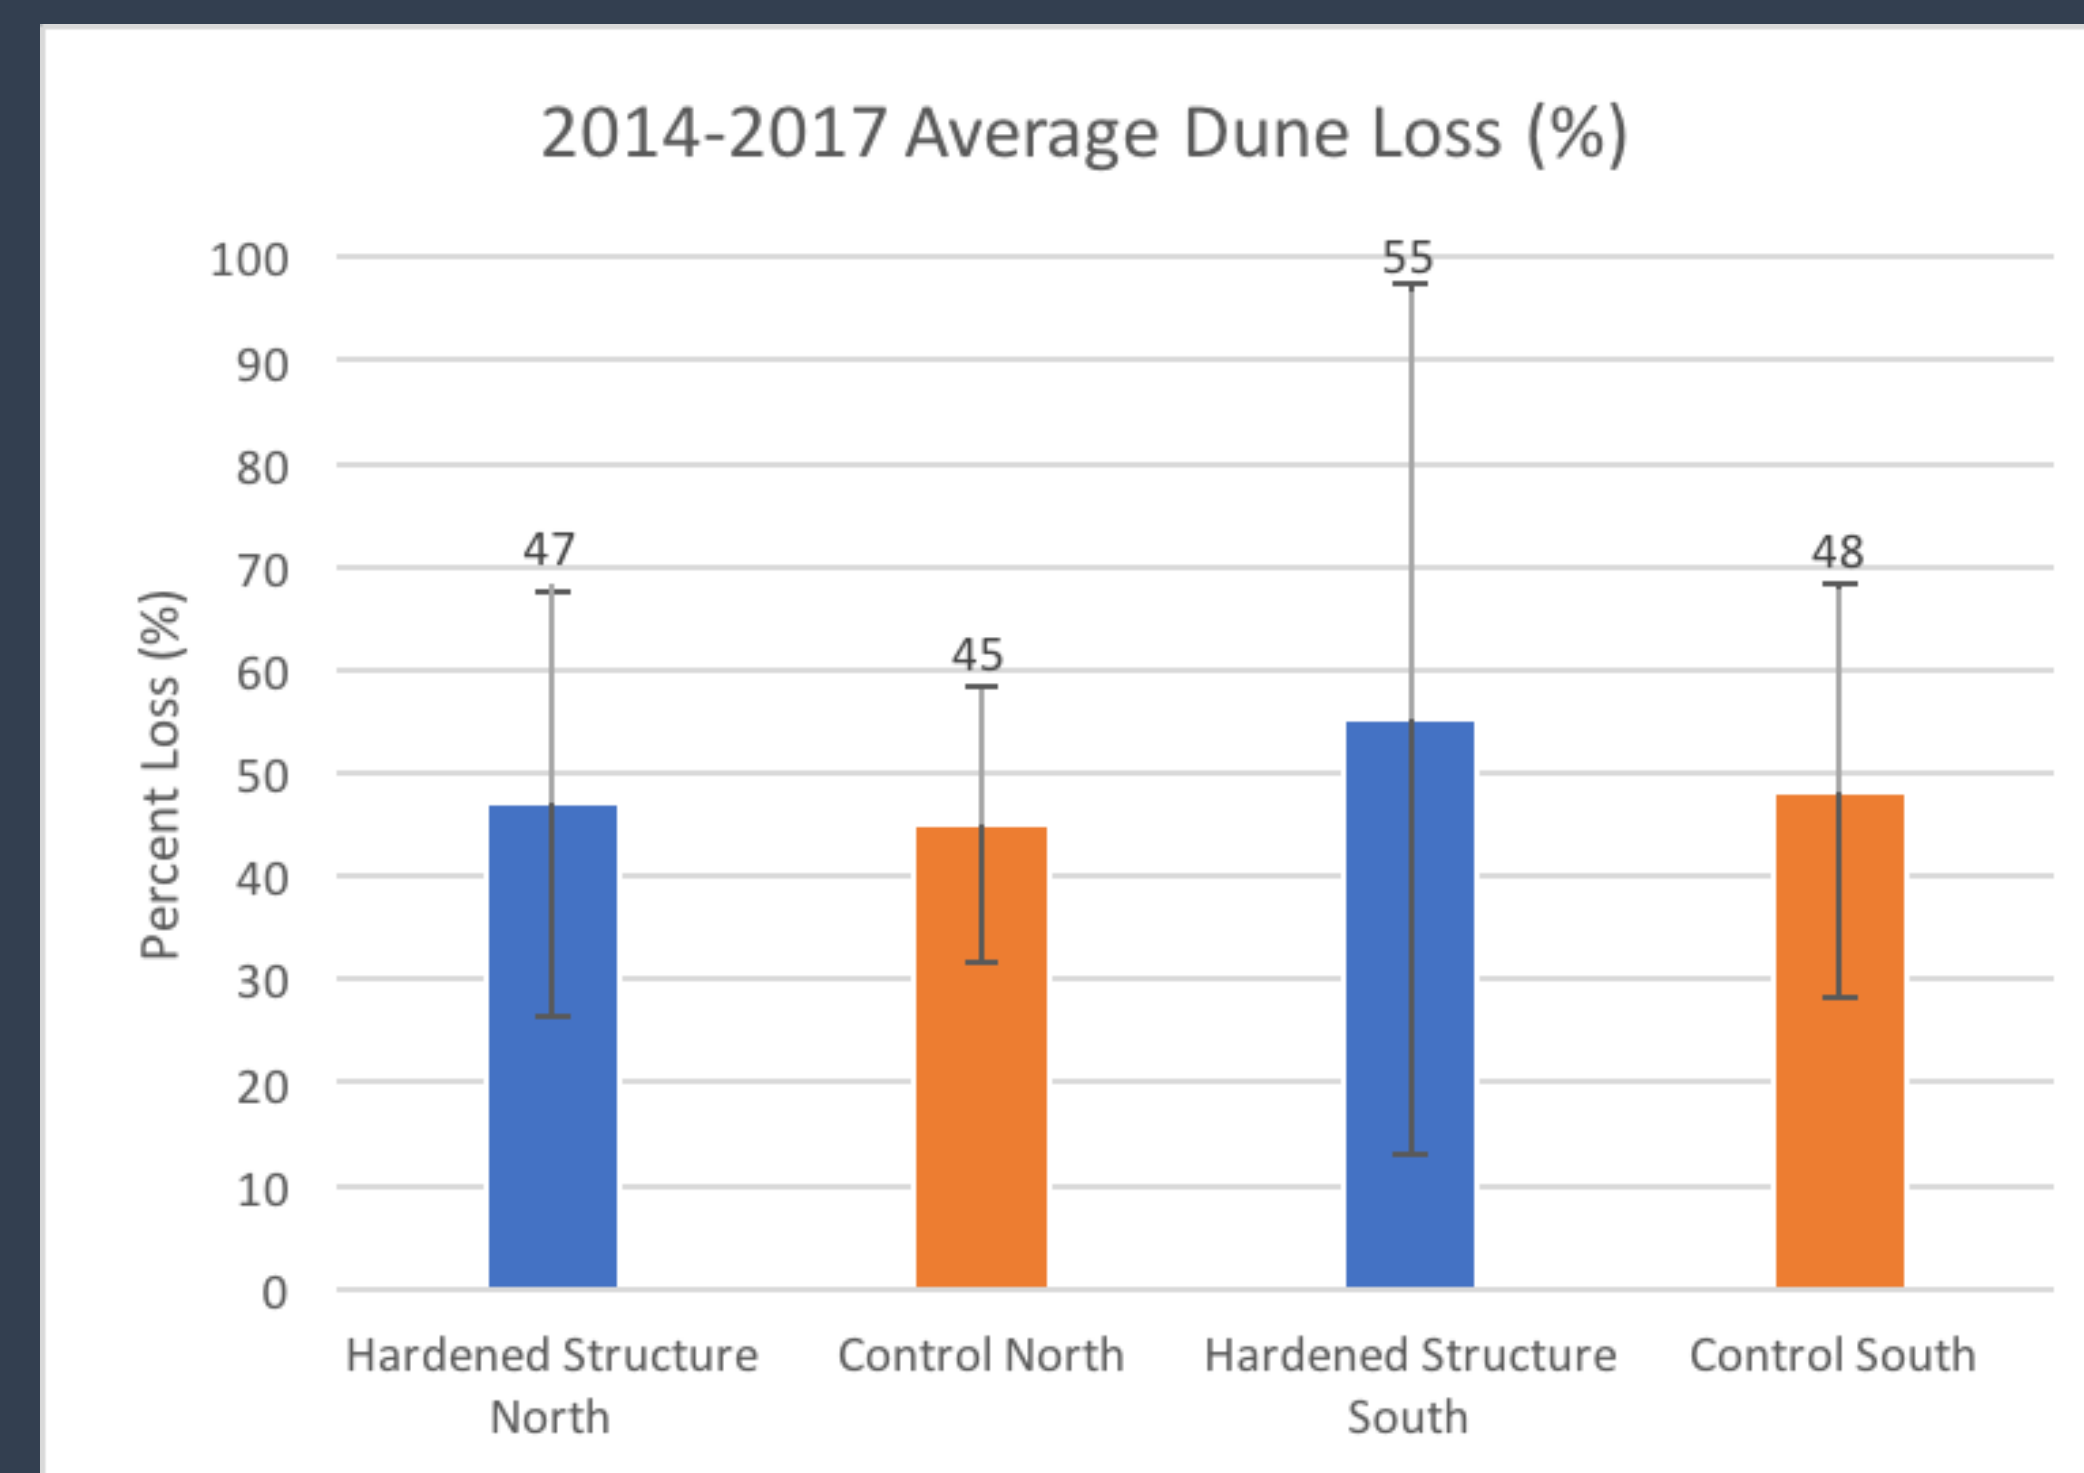
Graph 4: Geospatial Analysis: Average dune loss in percent between, pre Hurricane Matthew (2014) and post Hurricane Matthew (2017), directly north and south of the hardened structure sites and the control sites. The P-value of the hardened structures and controls for the north measurement was 0.42 and the P-value of the hardened structure and controls for the south measurement was 0.36. This shows that though there was erosion following the severe weather event there was not enough to fully support our hypothesis.

There was more erosion to the North of the hardened structures due to near shore currents transporting sediment away from north adjacent properties.

From the data collected while beach profiling selected sites the data represented increased erosion on the north adjacent properties.

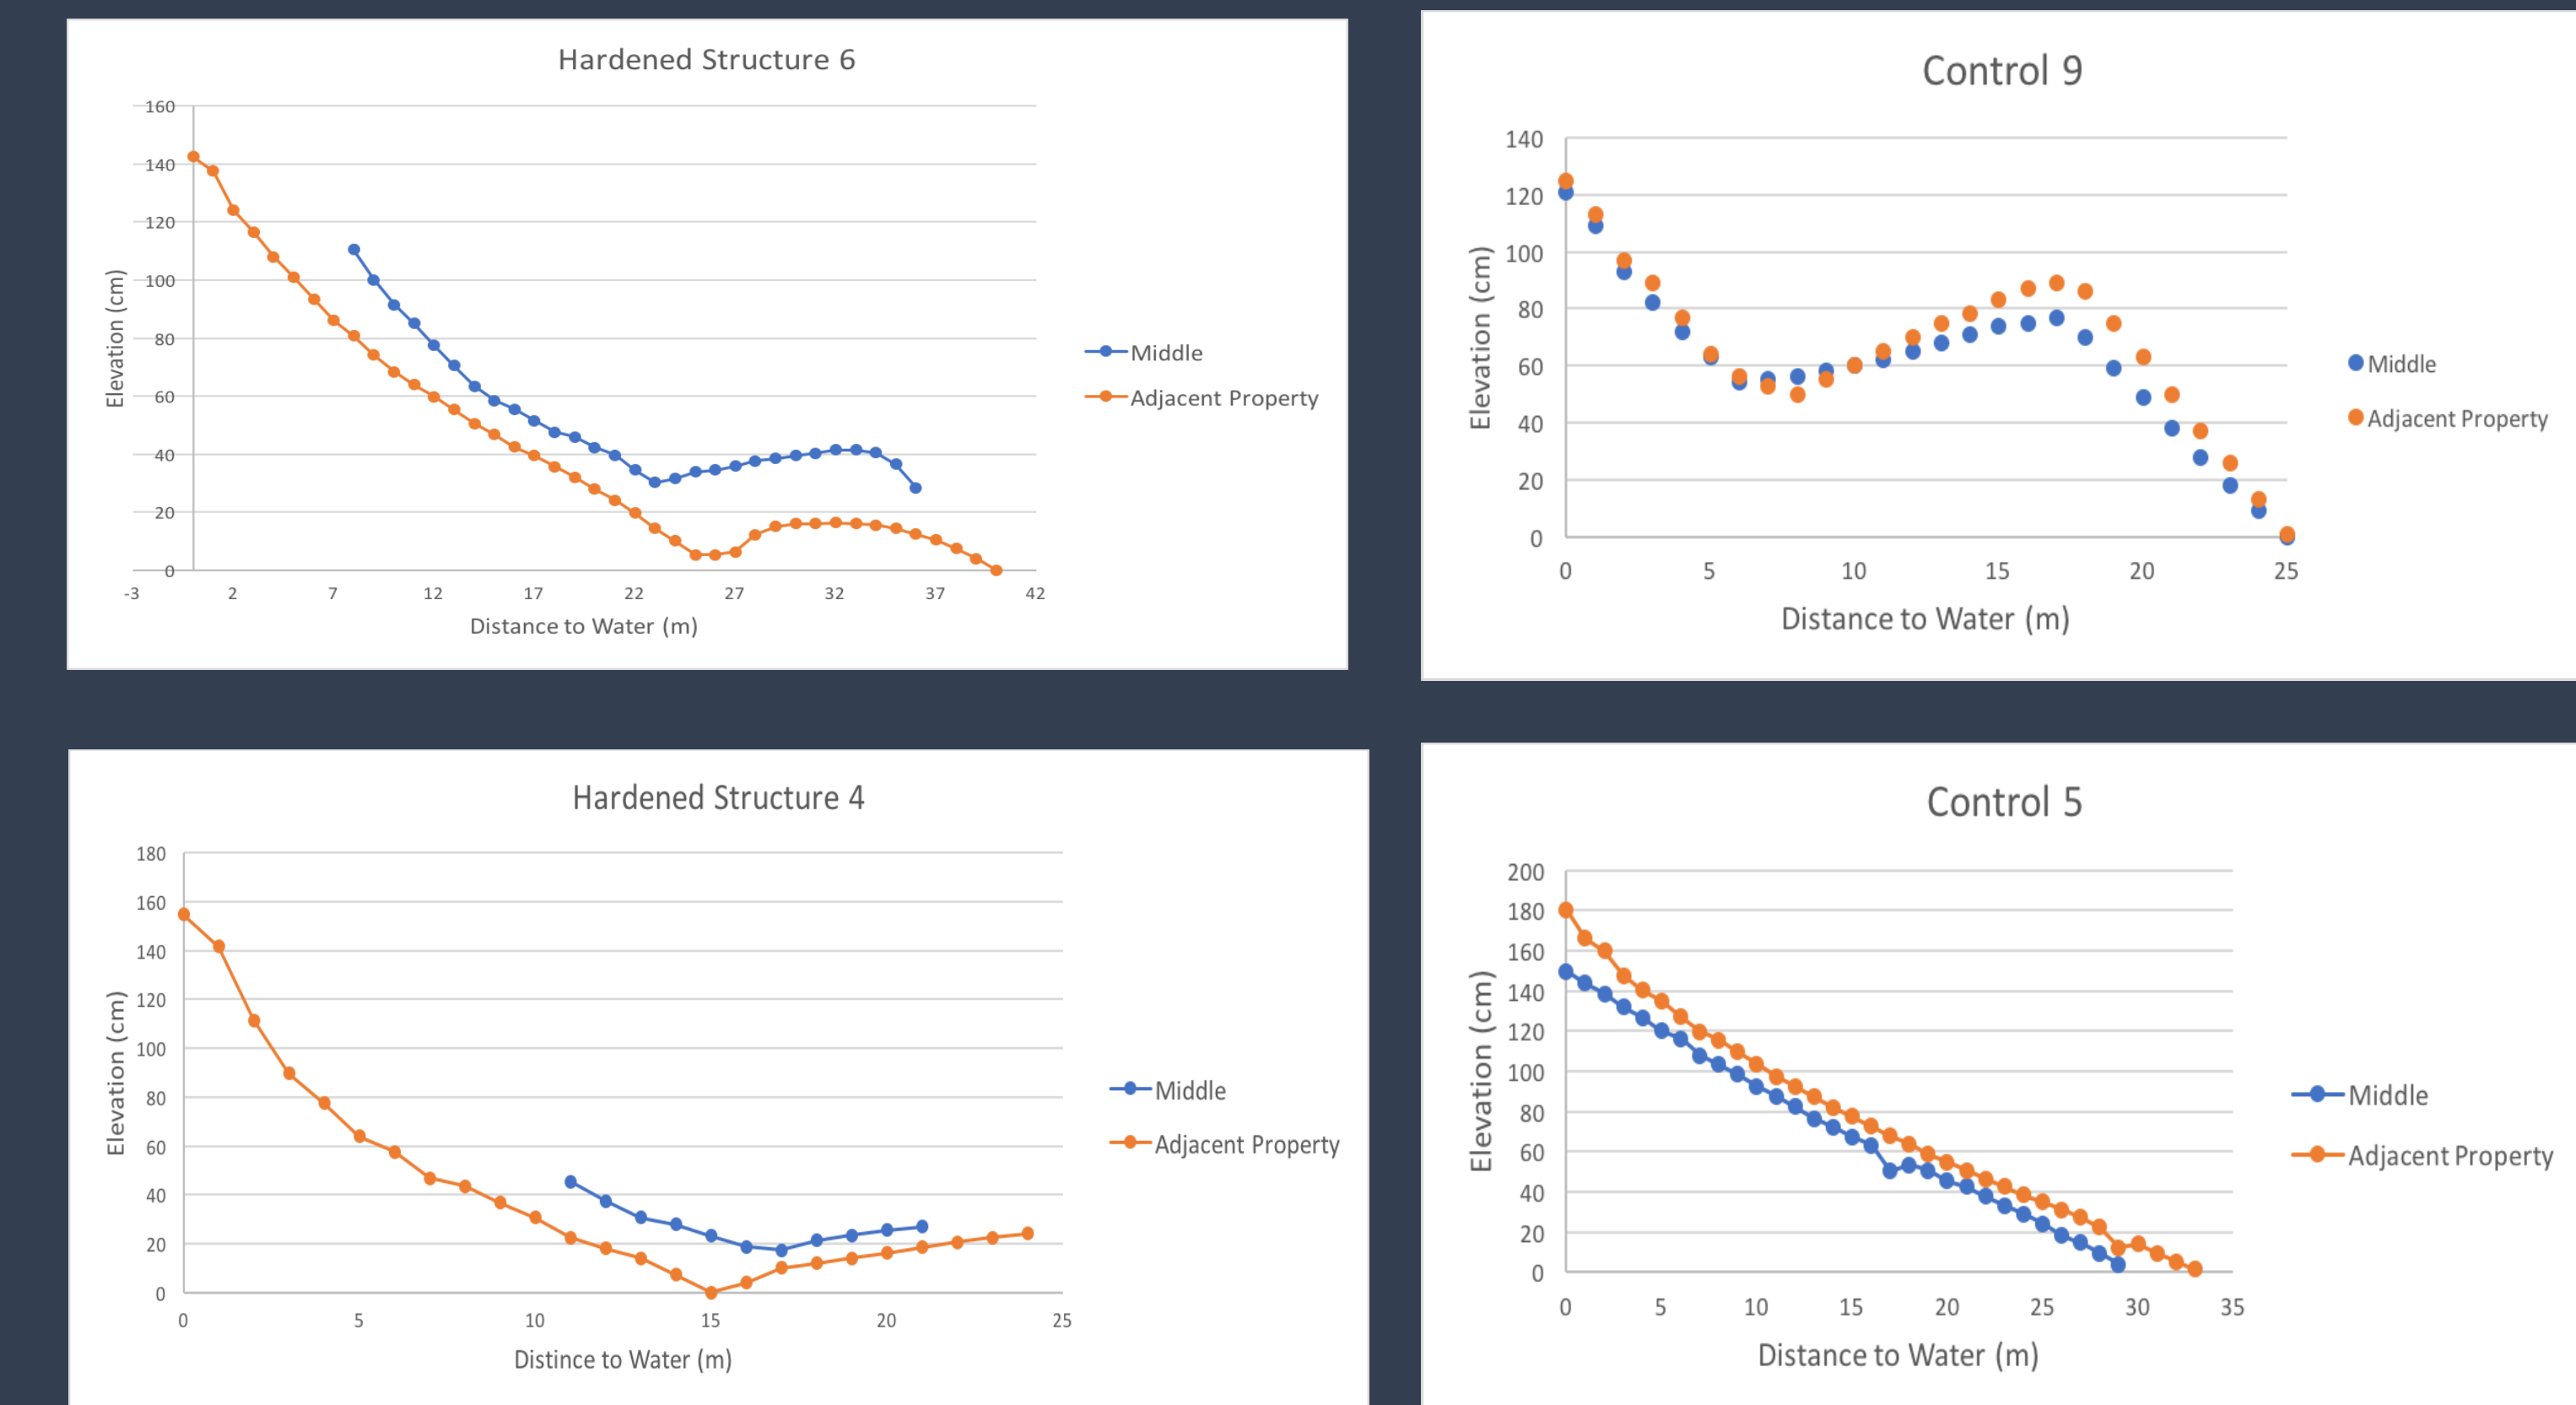
Graph 1: Cross sections of various Vilano beach locations. Six hardened structure sites (left) and six control sites (right) were measured.

Using the Emery method of beach profiling, we took elevation measurements in 1-meter increments starting from the top of the dune and ending at the water line.

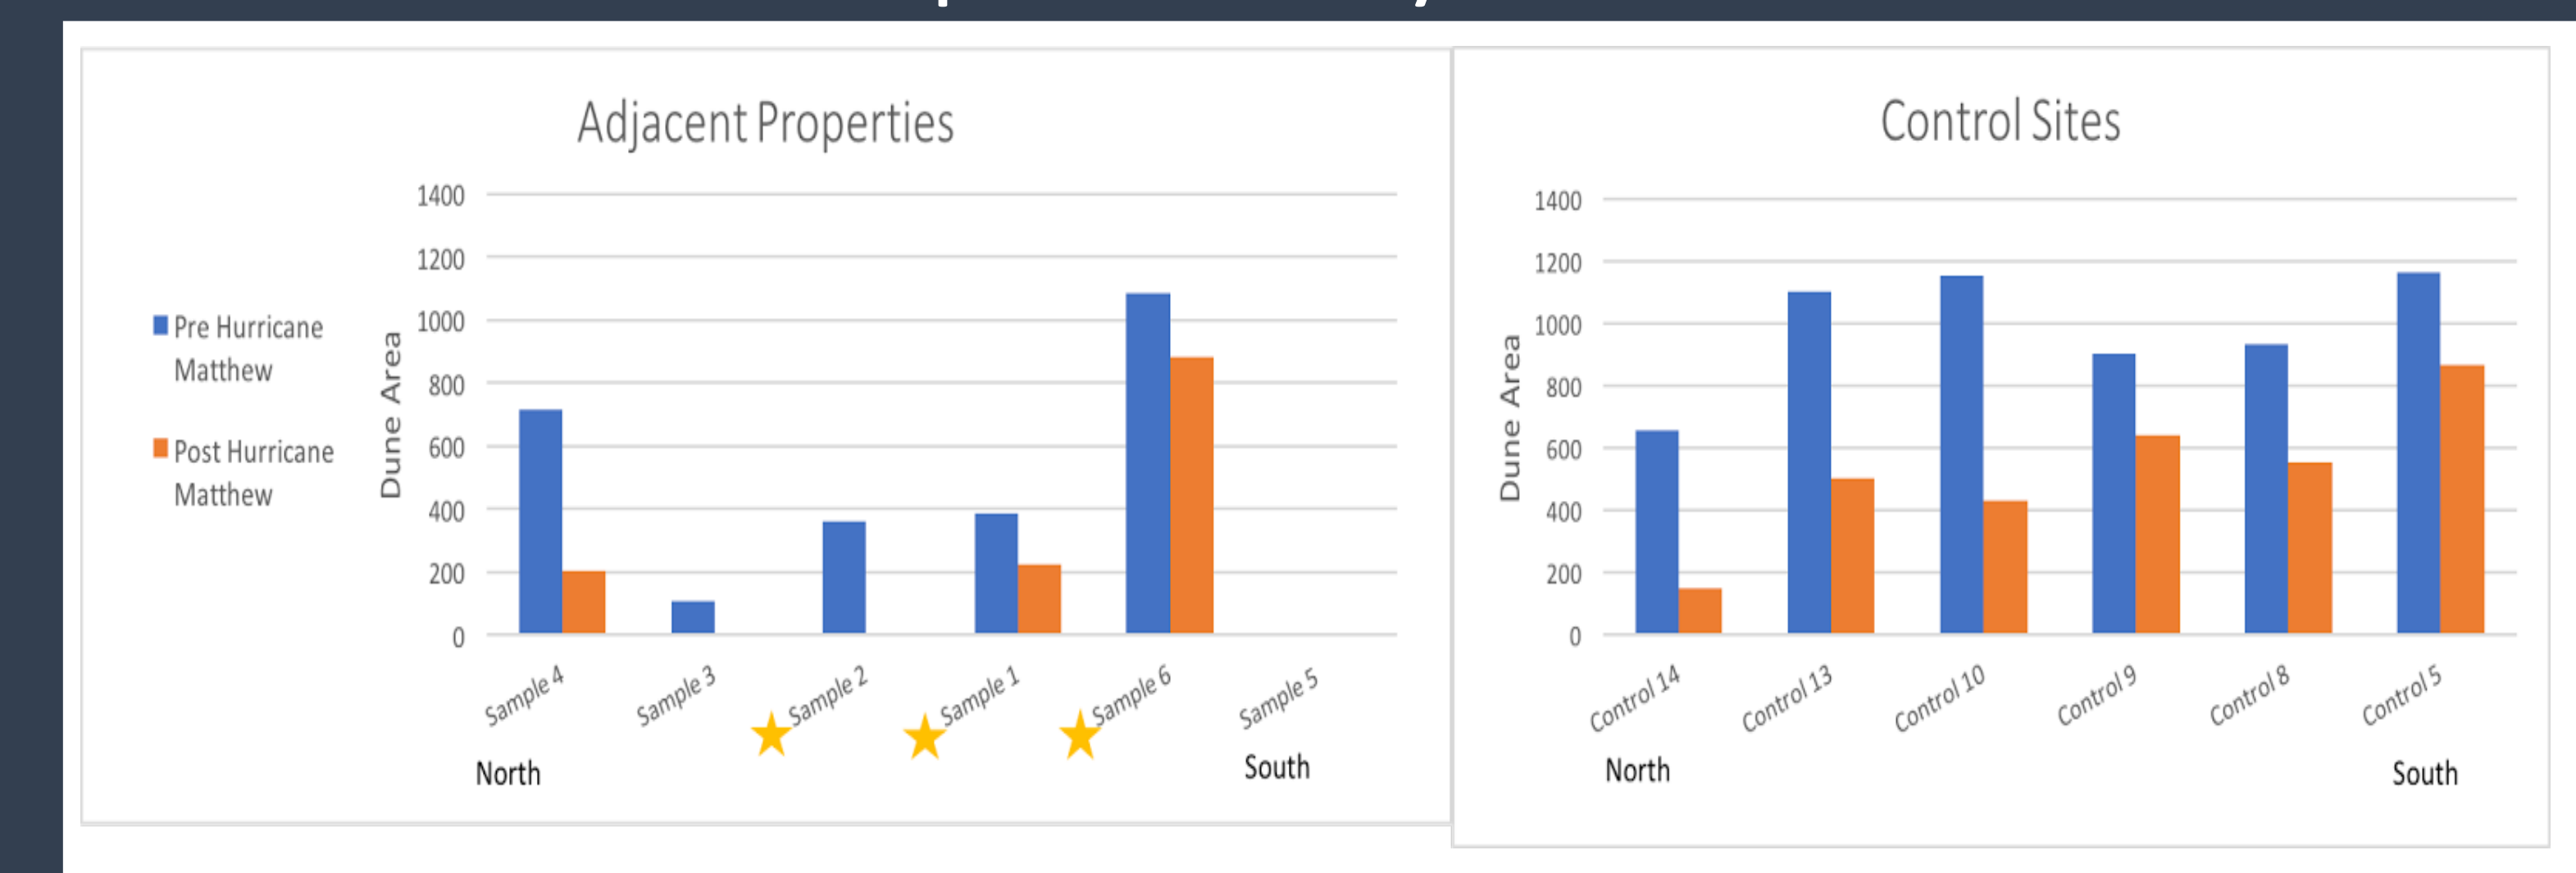
Graph 2: Geospatial analysis between pre Hurricane Matthew (2014) and post Hurricane Matthew (2017) satellite images, south of each individual hardened structure properties (left) and control sites (right). Yellow stars represent hardened structures constructed of rocks rather than a wall. P-value of hardened structure properties is 0.16 and P-value of control sites is 0.002 mean we can accept the hypothesis that there was erosion following Hurricane Matthew for the control sites but not for the hardened structure sites

We uploaded satellite imagery from 2014 pre-Hurricane Matthew and 2017 pre-Hurricane Irma. Within that, we utilized the polygon feature to measure the area of the dunes directly adjacent to the north and to the south of the properties.

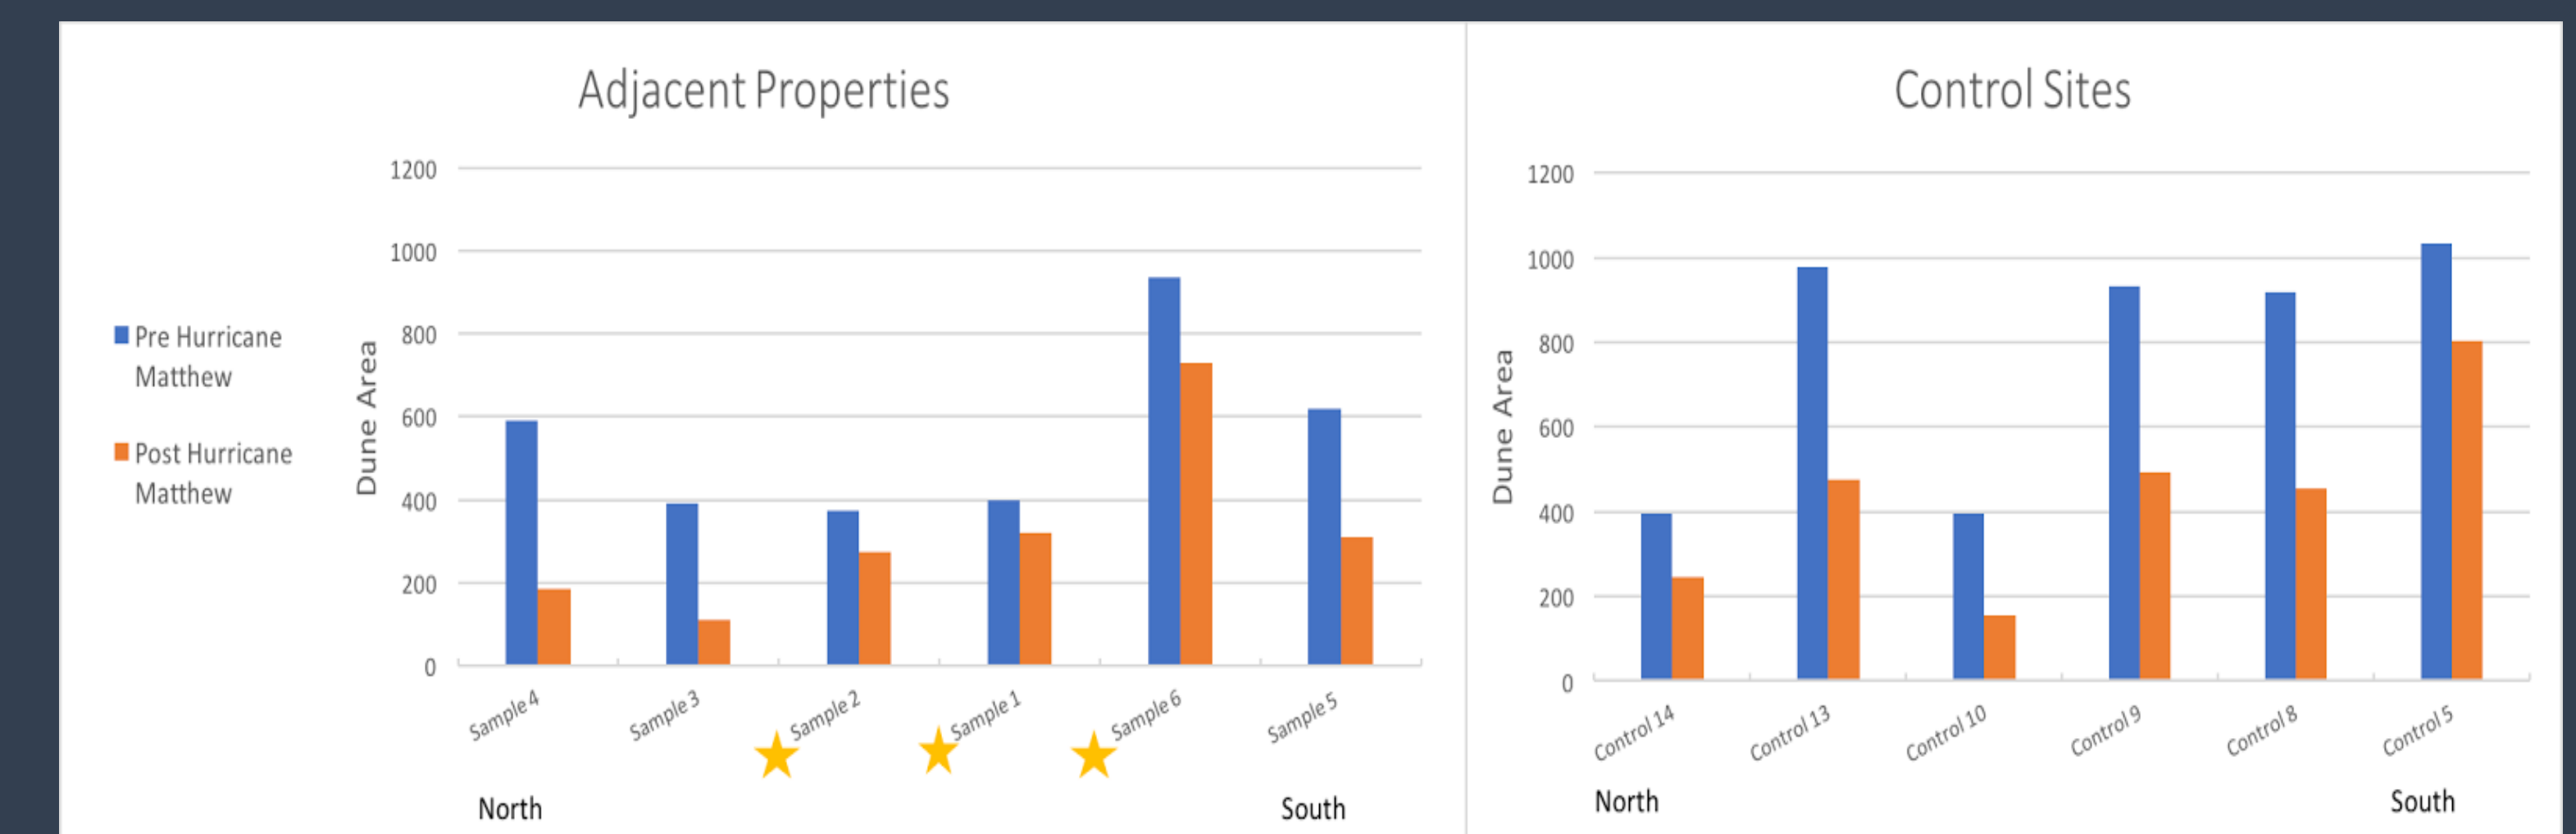
Graph 3: Geospatial analysis between pre Hurricane Matthew (2014) and post Hurricane Matthew (2017) satellite images, North of each individual hardened structure properties (left) and control sites (right). Yellow stars represent hardened structures constructed of rocks rather than a wall. P-value of hardened structure properties is 0.049 and P-value of control sites is 0.01 mean we can accept the hypothesis that there was erosion following Hurricane Matthew.
